Report No. A2240062506101

Sample Name SMA Antenna with elbow  
Type RFA-100-005  
Sample Receiving State Normal  
Sample Received Date Jan. 31, 2024  
Testing Period Jan. 31, 2024-Feb. 6, 2024

| No. | Test Item |
|---|---|
| 1 | IPX5 |

## Test Report

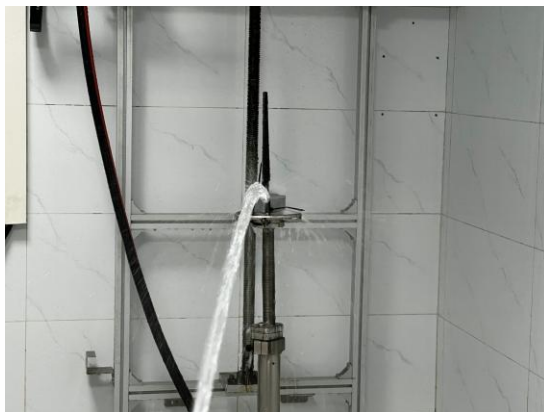
## Test Photo(s)

Water flow rate: 12.5L/min

Distance from sample surface to nozzle:2.5m~3m

Diameter of the nozzle:6.3mm

The rotation speed of the turntable: 1rpm

Test duration: 3 min

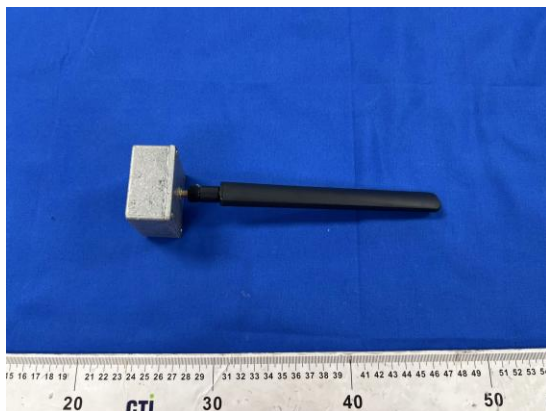
A2240062506101001

## Sample Photo(s) after the test

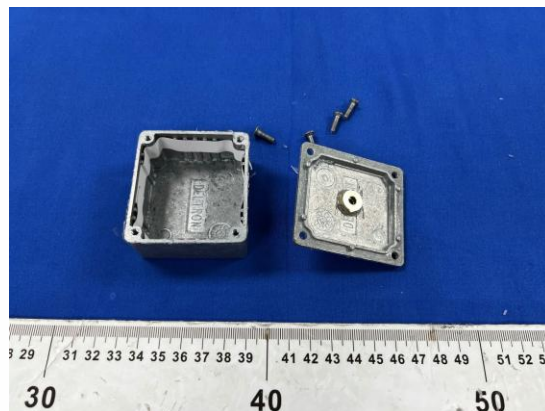
A2240062506101001 Survey position1

| Sample No. | Criterion | Survey position | Test result (Visual inspection) | Conclusion |
|---|--|---|---|---|
| A22400625<br>06101001 | No water enters the sample, and if water does enter, it cannot enter or endanger the live parts. | 1 | No water enters the sample. | Pass |

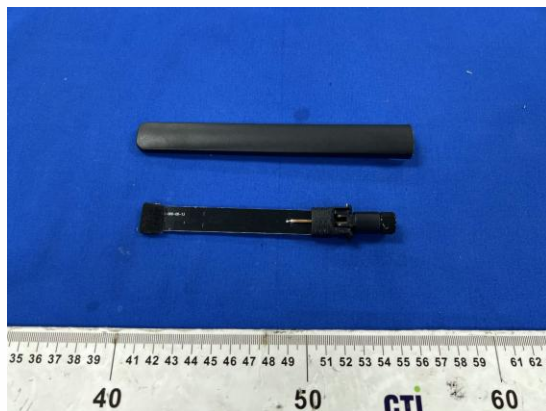
A2240062506101001 Survey position2

| Sample No. | Criterion | Survey position | Test result (Visual inspection) | Conclusion |
|---|--|---|---|---|
| | | 2 | No water enters the sample. | |
